**Fisheries Report
For the Streams in the
Proposed
Port Clements Shoreline Park Area**

The Village of Port Clements

June 15, 2001.

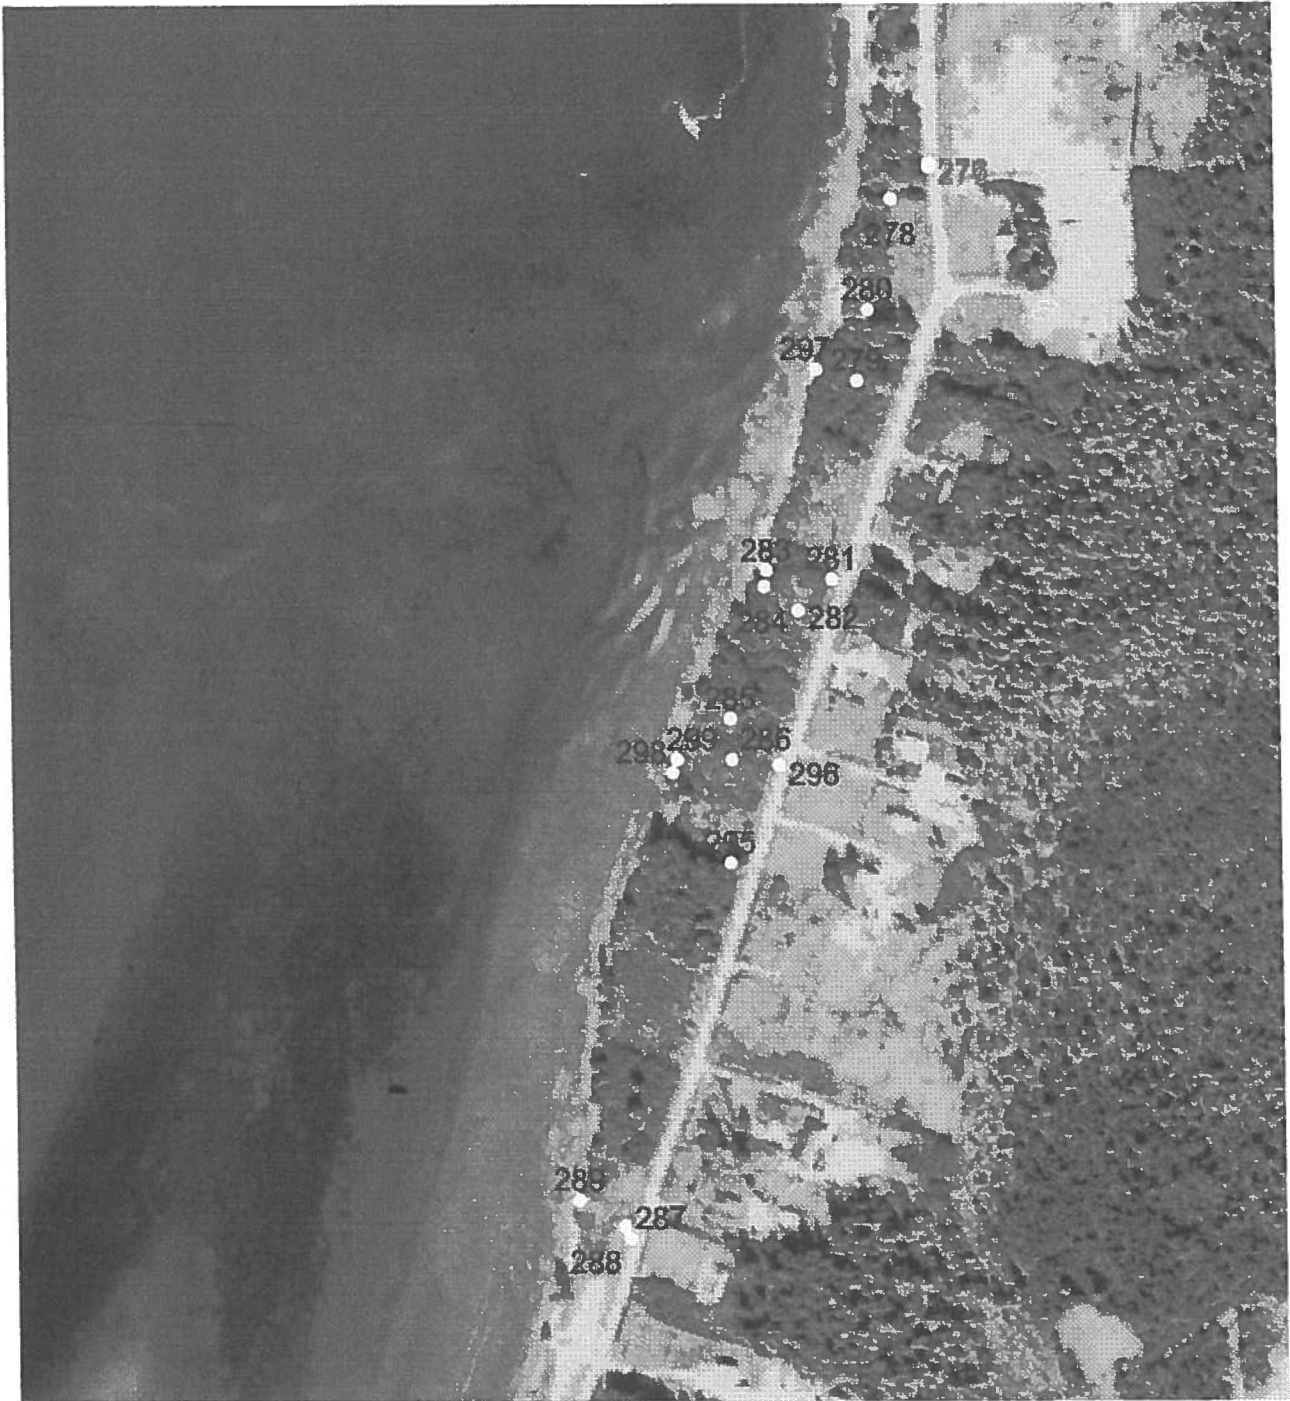
Figure 1. Aerial photo of northern half of study area including stream GPS points logged.

Table 1. Georeferencing table showing points logged at points on streams in the study area. Point numbers refer to points shown on air photos in Figures 1a and 1b.

The GPS points logged during this survey using the Garmin 12XL do not appear to be as accurate as we had hoped. This may be due to poor satellite geometry at the time of the survey or limitations of the equipment. The attached maps (Figures 1a, 1b) show the locations of the points logged. Because some of these points show up quite far from where we know they should land on the photo, it is strongly suggested that these points be confirmed with a more sensitive GPS unit or another mapping method.

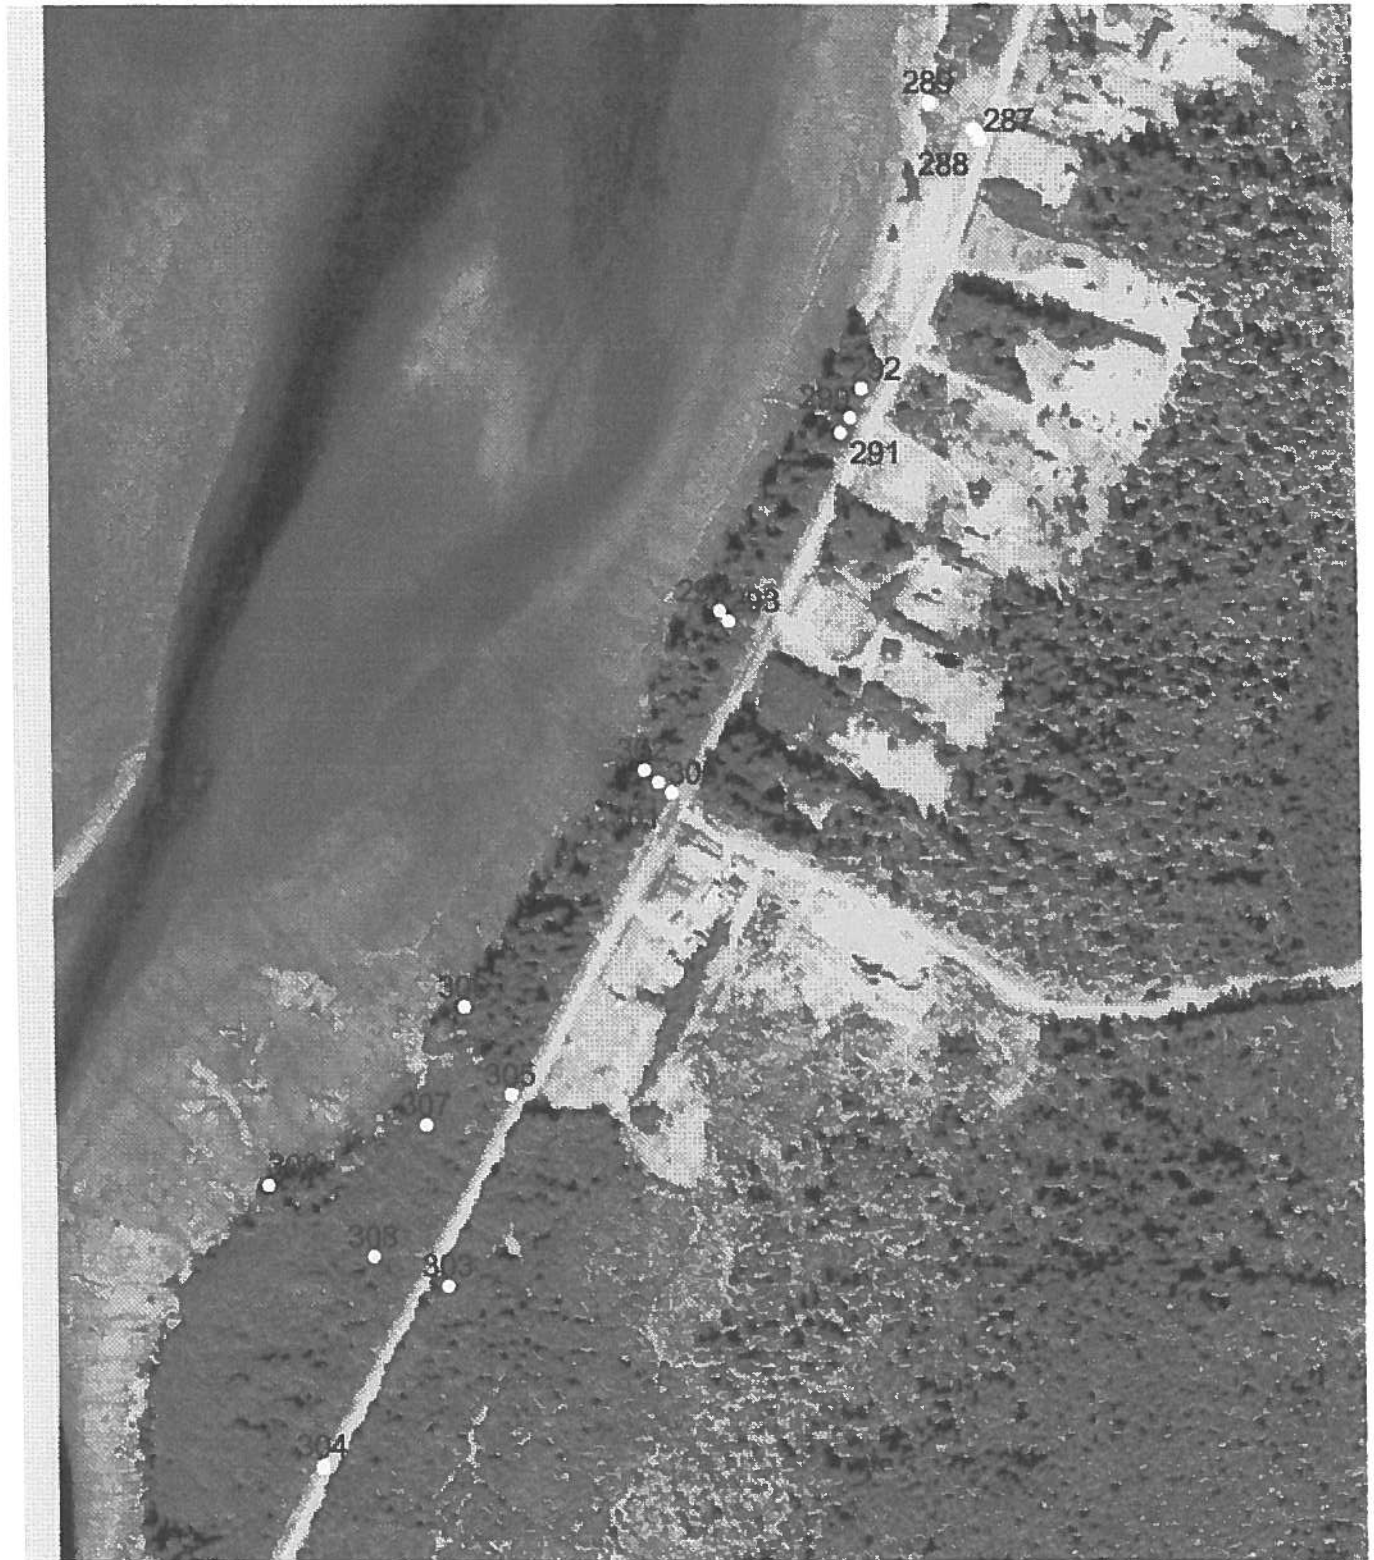
Figure 1b. South half of study area including GPS points logged.
